DAILY SUMMARY

Sequence: **No.1**
 Production: **FLEXBOX 3270TEU (2550units) Production**
 Date: **2024/9/9**

To: FLEX-BOX

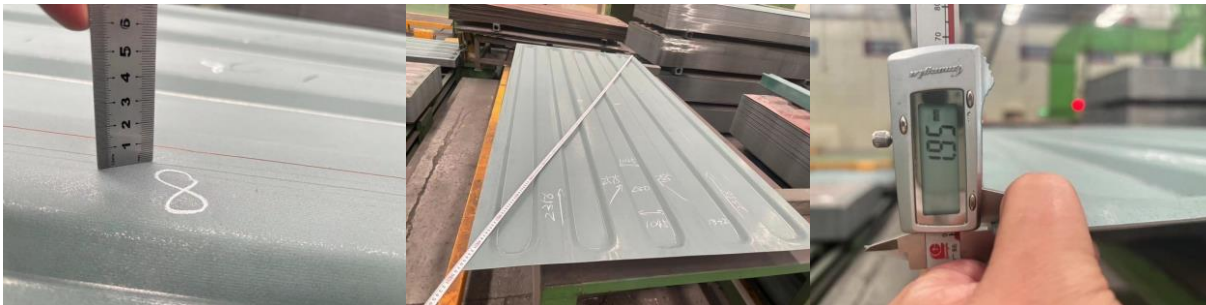
1. The forming process for 20EOD continued and finished today, checked the formed component dimension and thickness complied with drawing and specification.

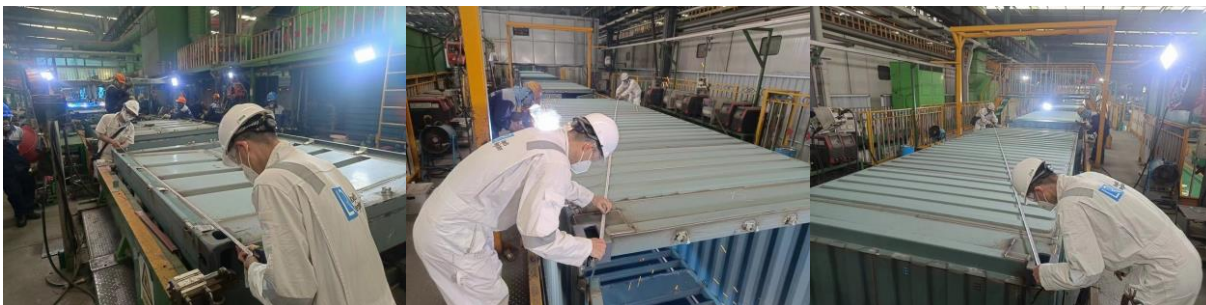
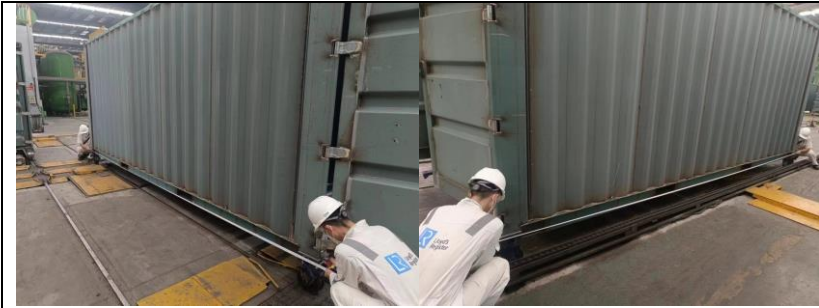
2. The sub assembly and main assembly continued today, checked the dimension complied with drawing, the diagonals were within 4mm.

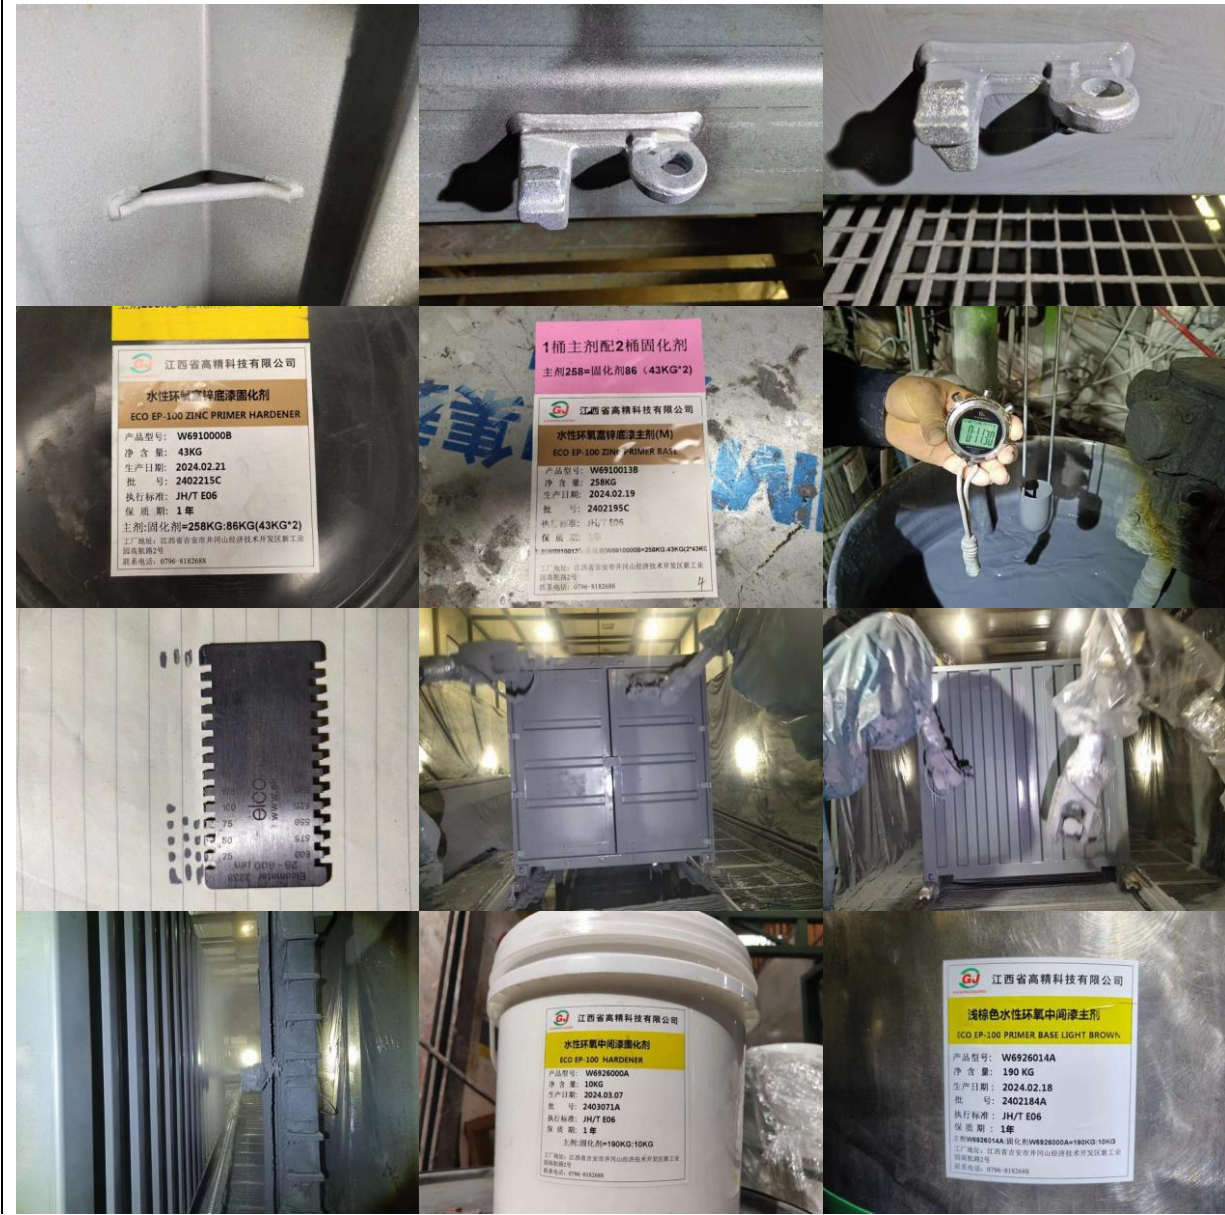
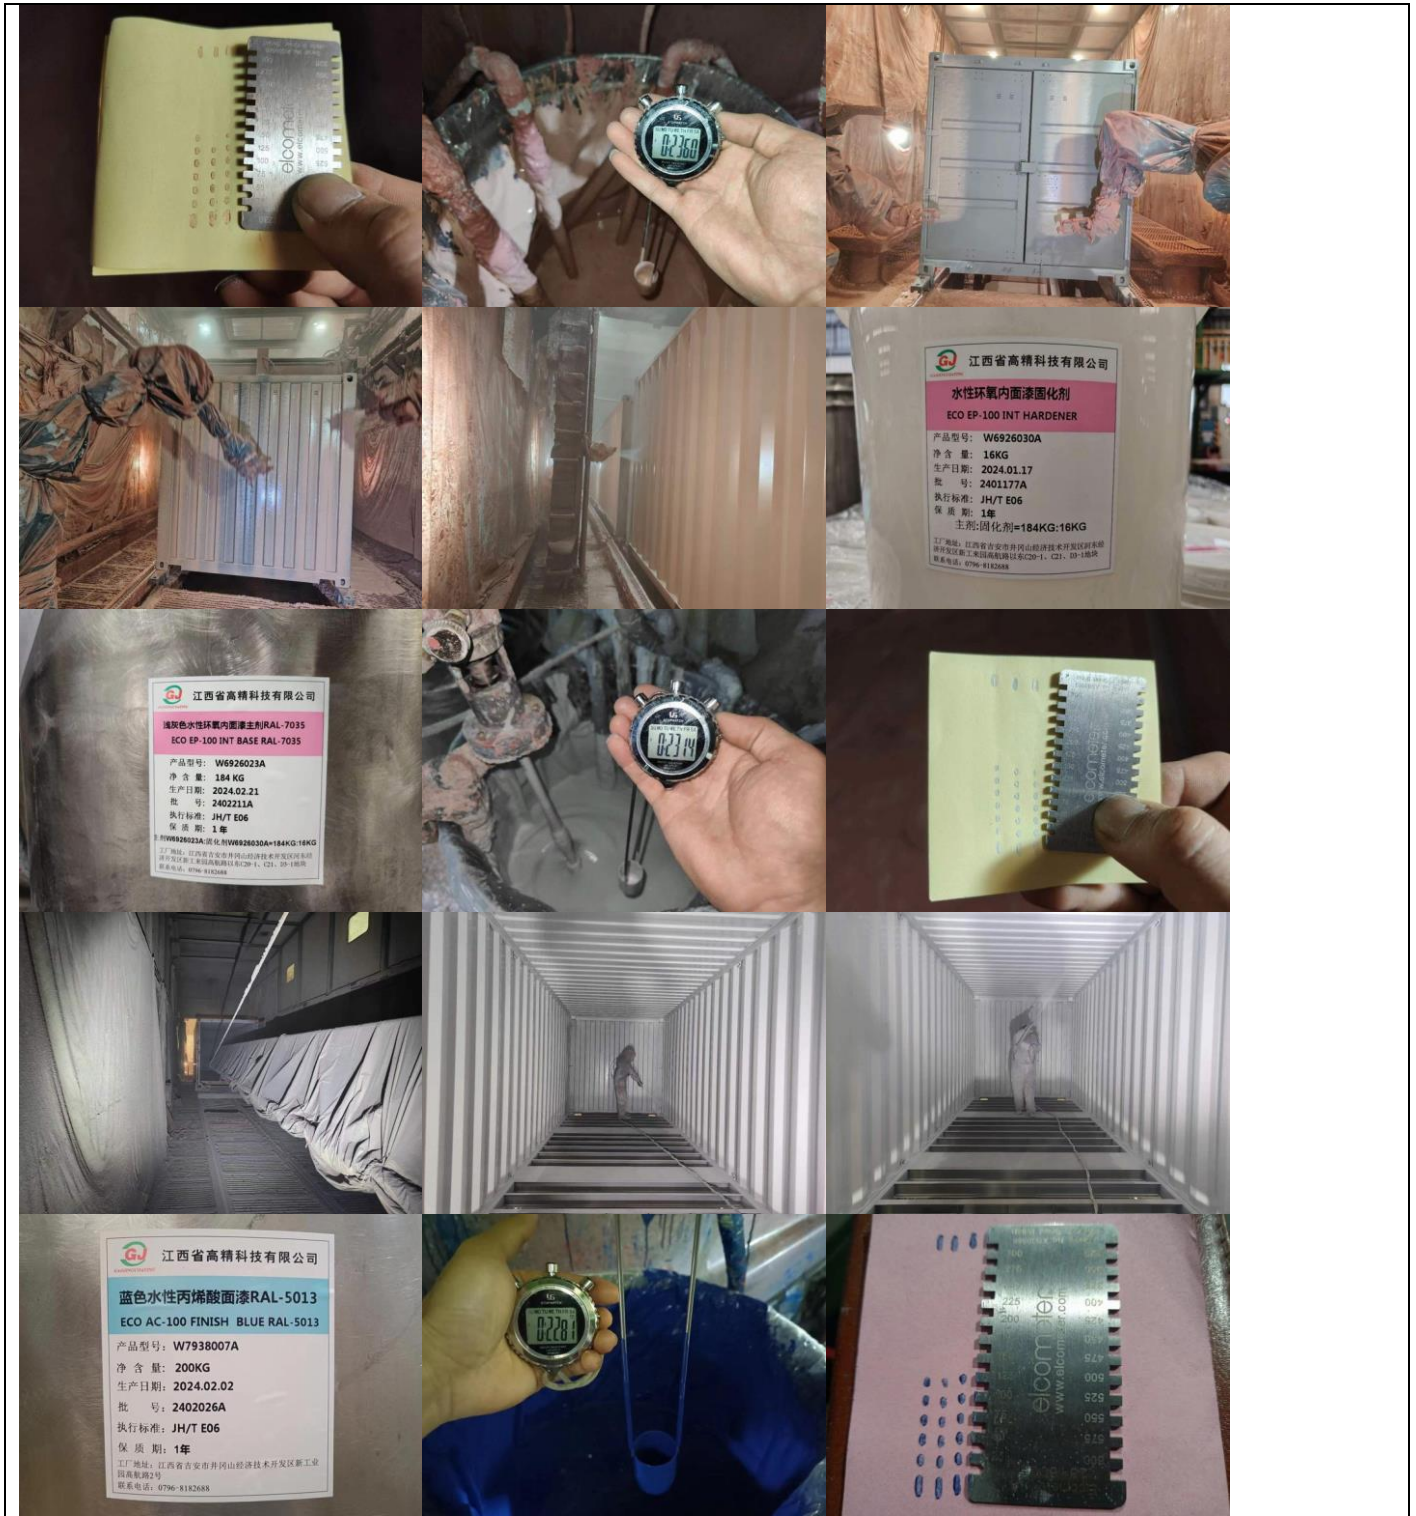
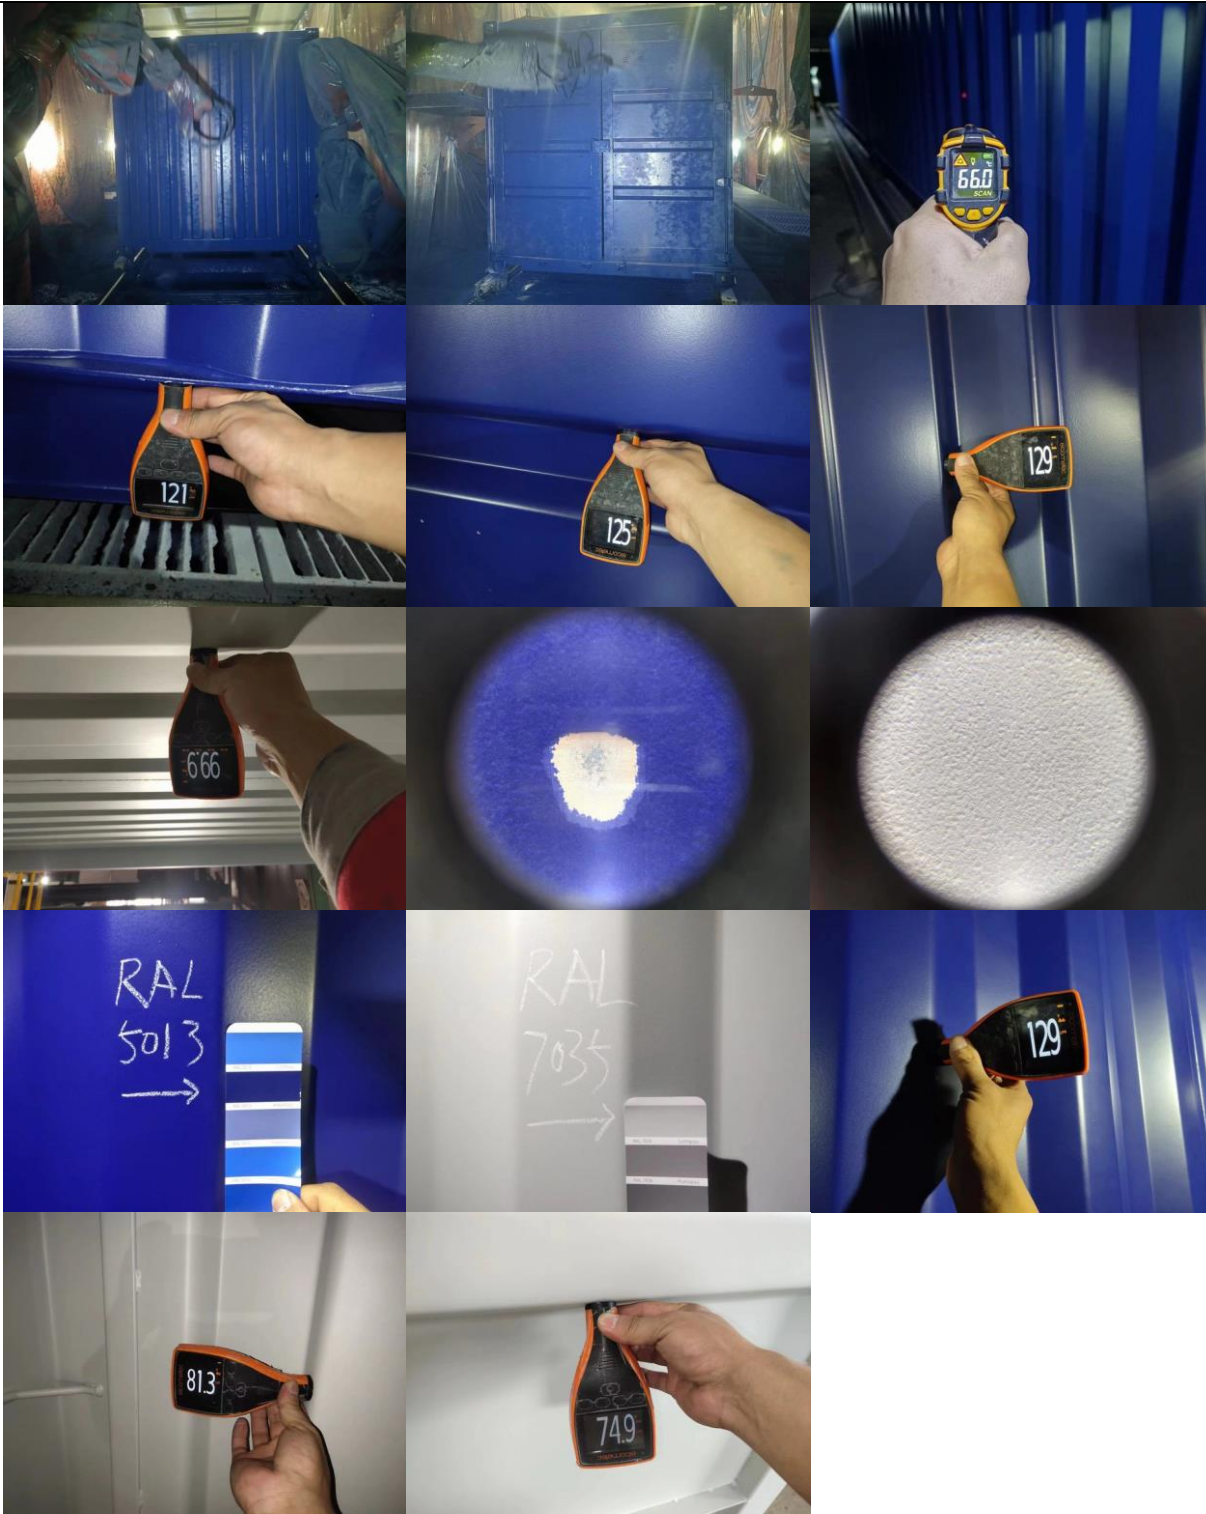
3. The 2nd shot blasting and paint application process commenced this afternoon, checked the condition on site, found the poor 2nd shot blasting on the interior corner post hidden area, rectified on site, condition improved later. Detail as below:

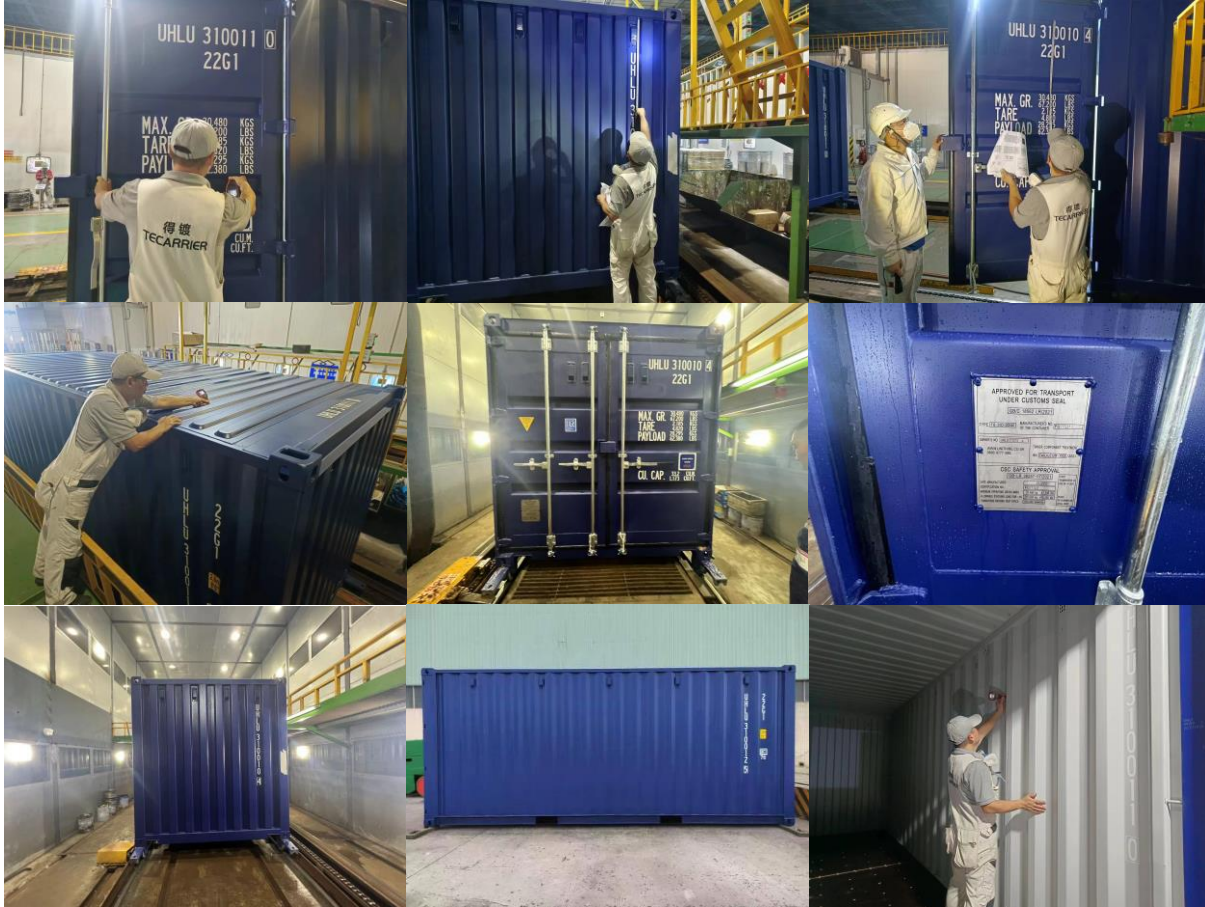
4. The final application commenced late this afternoon, checked the final application condition on site, details as below:
